TELEDYNE CONTINENTAL[®] AIRCRAFT ENGINE
CRITICAL SERVICE BULLETIN
COMPLIANCE NECESSARY TO MAINTAIN SAFETY

Category 2
CSB07-2

SUBJECT: TURBOCHARGER WASTEGATE OIL INLET FITTING
INSPECTION and REPLACEMENT

PURPOSE: To provide instructions for the inspection of the turbocharger wastegate oil inlet fitting for possible chafing on the adjacent structure and to provide instructions for fitting replacement.

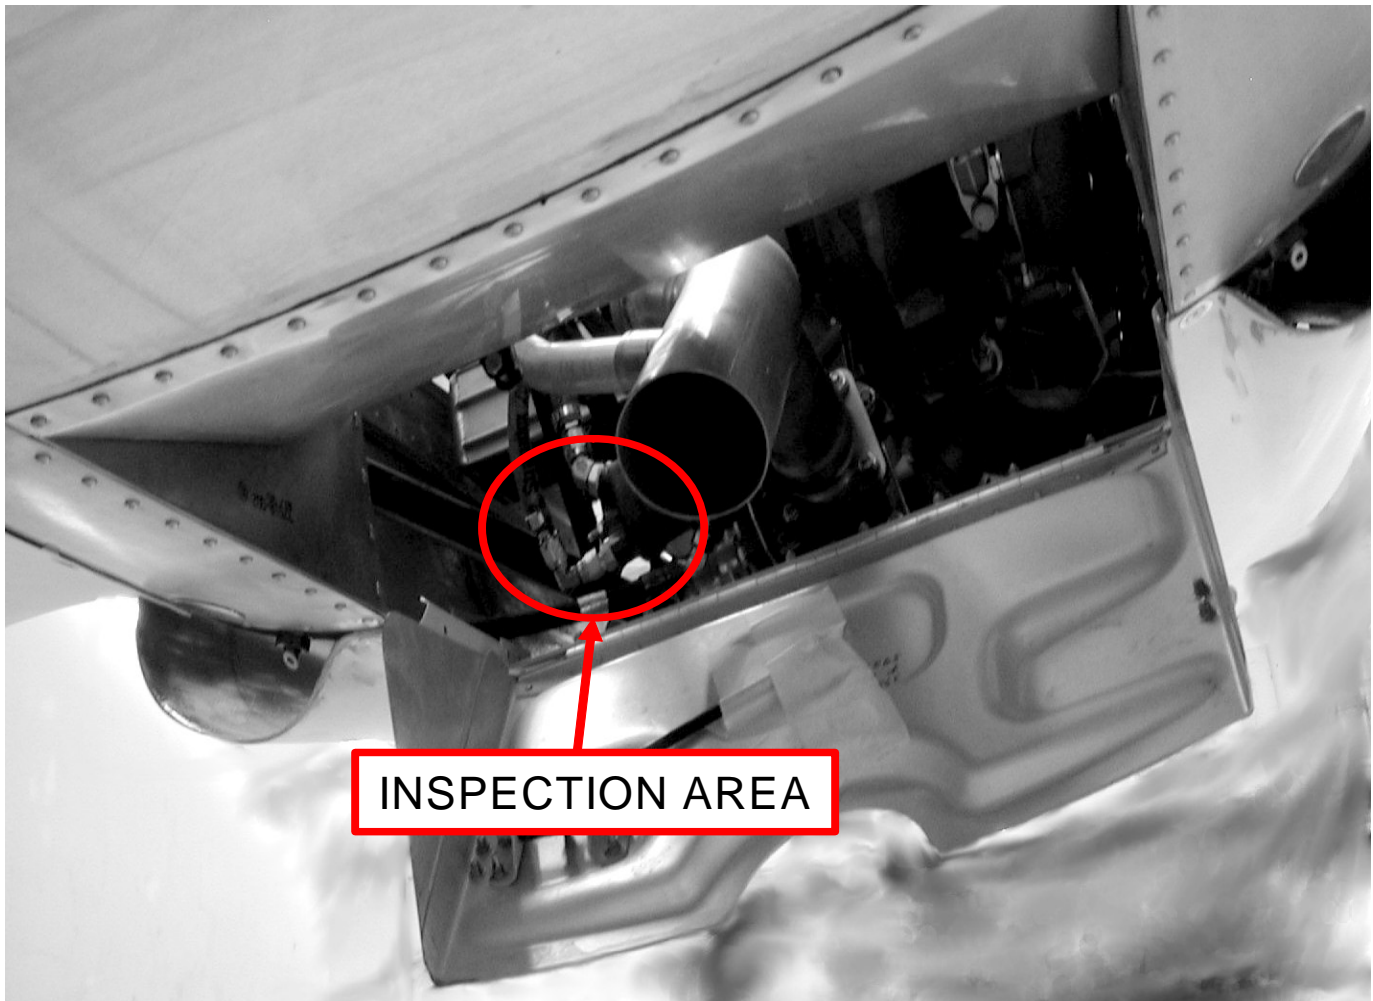
FIGURE 1
INSPECTION AREA

1. Using the airframe manufacturer's maintenance instructions, open or disconnect each engine cowl flap to allow access to the wastegate actuator. (Reference Figure 1)
2. Inspect the oil inlet fitting of the wastegate actuator.
3. If the fitting is a one-piece 90° fitting as shown in Figure 2A, no further action is required. Reassemble the previously removed airframe components using the applicable airframe manufacturer's maintenance instructions. Make engine log book entries for each engine inspected certifying compliance with this Critical Service Bulletin.
4. If the fitting is a two piece assembly (straight fitting and 90° fitting) as shown in Figure 2B, proceed to the fitting replacement instructions contained in this Critical Service Bulletin.

1. Using the airframe manufacturer's maintenance instructions, open or disconnect the engine cowl flaps and remove the engine cowling as necessary to allow access to the wastegate actuator. (Reference Figure 1)

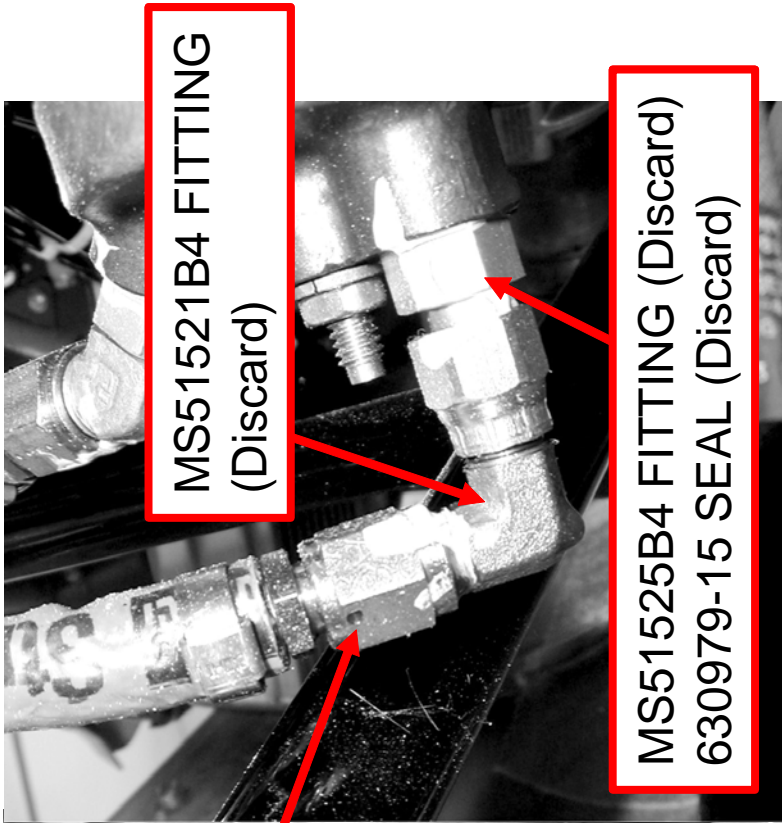
**FIGURE 2B
OLD INSTALLATION**

Teledyne Continental Motors (TCM) has received a report from the field of possible interference between the turbocharger wastegate oil inlet fitting and the adjacent airframe engine mount structure. Damage to the wastegate oil inlet fitting could lead to fitting fracture and subsequent loss of engine oil.

3. Remove the 90 degree fitting P/N MS51521B4, straight fitting MS51525B4, and O-ring seal P/N 630979-15 from the oil inlet on the wastegate and discard. (Reference Figure 3)
