Service Letter

Letter No. 026

NOTIFICATION OF PRECISION AIRMOTIVE LLC. MANDATORY SERVICE BULLETIN PRS-107 REV. 1 (FAA Emergency AD 2008-06-51)

SUBJECT: HEX PLUG 383493 COMING LOOSE FROM REGULATOR COVER

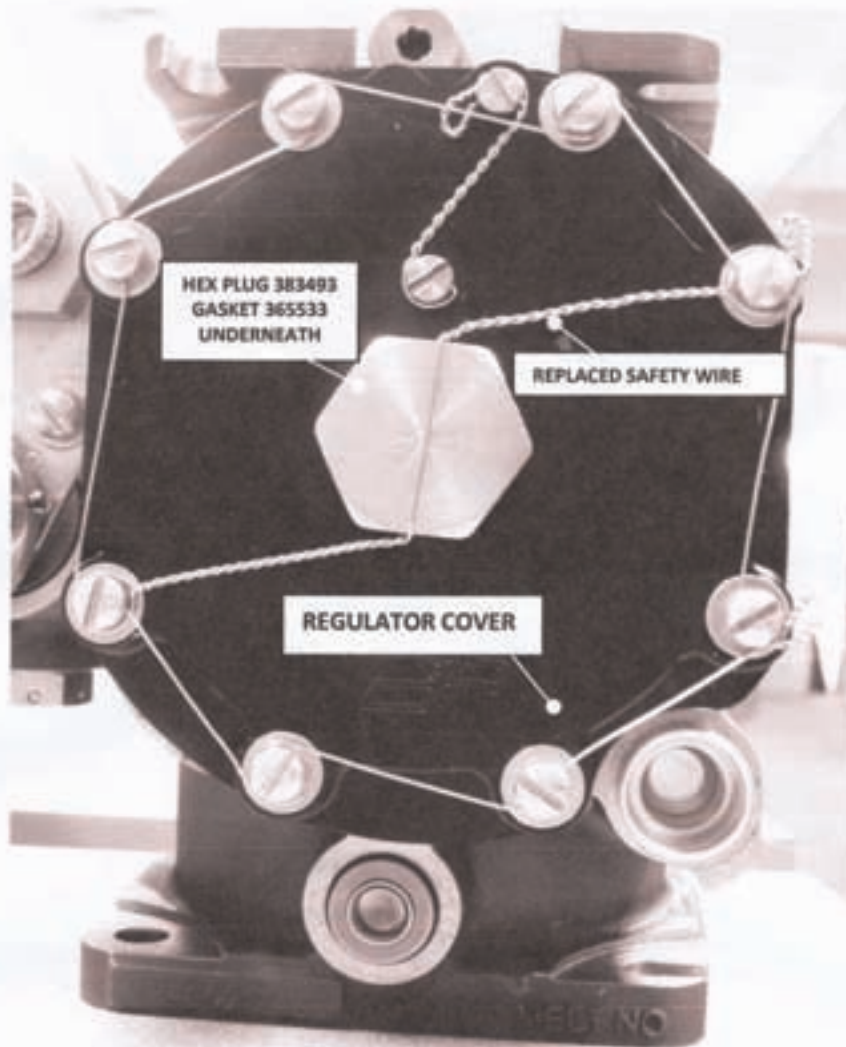
Note: Plug safety wire is wrapped around regulator screws under existing wire. It does not go through the holes in the screws.

7. The hex plug must be safety wired with .025 inch diameter wire to the regulator cover as shown in the figure below. The wire shall pass thru the plug such that it pulls the plug in the tightened direction and does not touch the corners of the hex on the plug.
