SLICK Service Bulletin

SB1-15A

SUBJECT: Potential decreased service life of Slick 4-cylinder magneto distributor gear assemblies. Based on process and component improvements following the initial release of this service bulletin, the serial number range is being extended in this revision. Magnetos previously returned for compliance to SB1-15 must be returned or inspected for compliance to this revision SB1-15A.

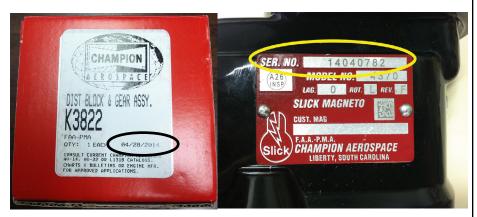
Figure 1. Replacement Kit Box Label Date Code Figure 2. Magneto ID Label Date Code

AFFECTED: The following 4-cylinder magnetos with serial numbers between 08090001 thru 16071072, K3822 distributor block replacement kits, and K3008 distributor gear assemblies dated September 26, 2008 thru September 1, 2016:

NOTE: 08090001 = SN manufacture date of September 2008 and 16071072 = SN manufacture date of July 2016

If it is not possible to confirm the version of the distributor gear that is installed in a given magneto from maintenance records, the magneto may be removed from the engine in order to have the housing and distributor block removed to allow visual inspection of the distributor gear. Distributor gears with Copper electrodes must be replaced with distributor gears with Monel electrodes.

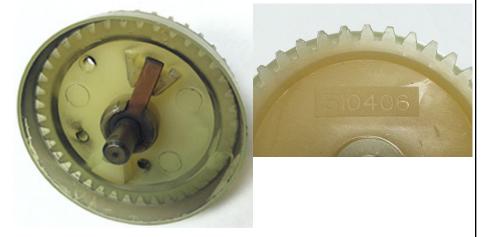
Figure 3. Affected K3008 Distributor Figure 4. K3008 Distributor Gear **Gear With Copper Electrode**

The initial release of SB1-15 was based on a limited number of field reports and product returns, Champion Aerospace has identified a possible condition in the distributor gear assemblies of 4-cylinder magnetos that can lead to decreased service life. Some of the returned products contained distributor gears exhibiting loosening of the electrode finger. This condition was observed in magnetos with a varying number of service hours. Typical symptoms are unusual RPM drop during magneto check, difficulty starting, and/or rough running engines.

Marked 510406 (Backside)

COMPLIANCE: REMOVE affected distributor gear assembly in subject magnetos and REPLACE with replacement distributor gear assembly, K3008, as soon as possible, not to exceed the next 50 hours. Document Service Bulletin compliance as written entry in applicable Aircraft and/or Engine logbook.
