SB3-08

SLICK **Service Bulletin**

SUBJECT: Mandatory inspections on all Slick 4300/6300 and LASAR™ 4700/6700 magnetos

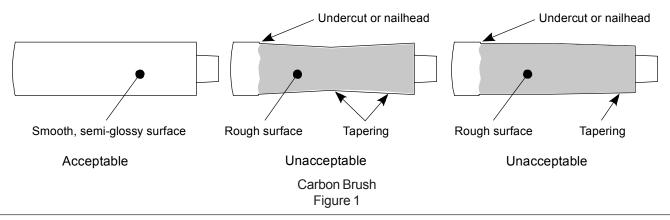
INSTRUCTIONS: 1. Use lighted magnification (4X minimum) to inspect carbon brush for rough surface and possible tapering. REPLACE CARBON BRUSH THAT SHOWS ANY OF THE **UNACCEPTABLE CONDITIONS SHOWN IN FIGURE 1 PER THE APPLICABLE** MAINTENANCE AND OVERHAUL MANUAL.

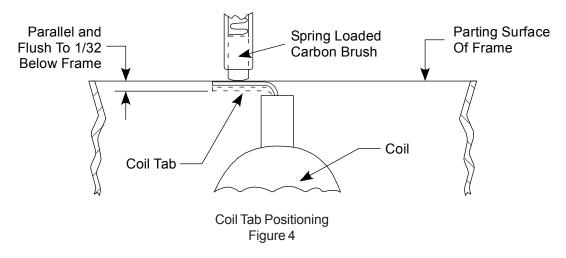
<u>CAUTION:</u> IF THE COIL TAB PROTRUDES ABOVE THE MAGNETO FRAME, IT CAN MAKE DIRECT CONTACT WITH THE DISTRIBUTOR GEAR AXLE AND CAUSE THE MAGNETO TO MALFUNCTION.

5. Prior to installing distributor block, make sure coil tab is parallel to and flush with frame mating surface to within 1/32 inch. See Figure 4.
